Hex Chrome Free Coatings for Electronics Overview

Hexavalent Chrome Free Coatings – Ground Support Development and Operations Program (GSDOP)

Electrical Connectors – Electrical Bonding

- Evaluate and test pretreatments not containing hexavalent chrome on electronics housing applications for use on Ground Support Equipment (GSE) and Electrical Ground Support Equipment (EGSE)

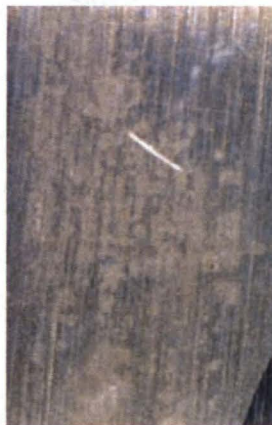
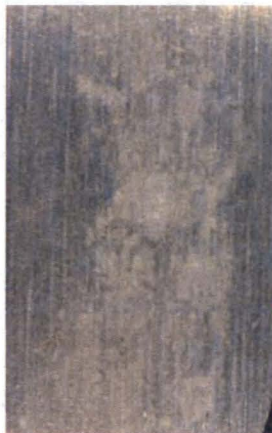
6061-T6	@ 168	@ 336	@ 504
1200S 60 01 30	0	0	*5+
1200S 60 02 30	0	0	*10+
1200S 60 03 30	0	0	*10+

* Large spots / corrosion clusters

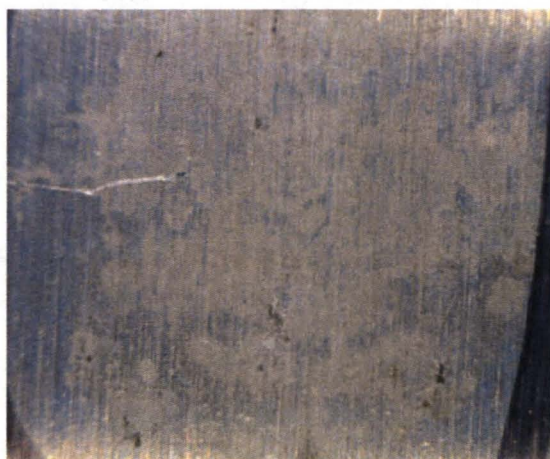
6061-T6	@ 168	@ 336	@ 504
1200S 60 01 3	2	0	*5+
1200S 60 02 3	0	0	*10+
1200S 60 03 3	4	0	20+

* Large spots / corrosion clusters

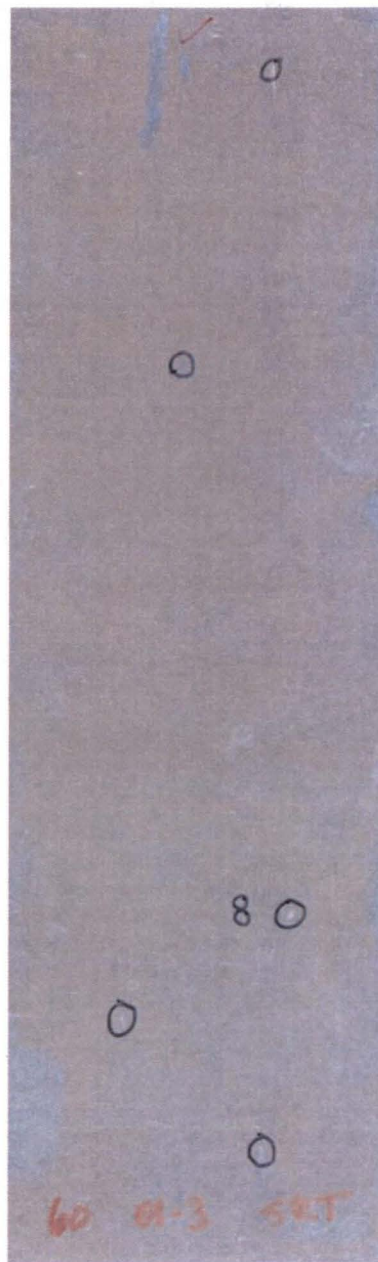
6061-T6	@ 168	@ 336	@ 504	@ 672
SRT 60 01 3	0	0	0	7
SRT 60 02 3	0	0	0	8
SRT 60 03 3	0	0	1	*5+
* large corrosion spots observed

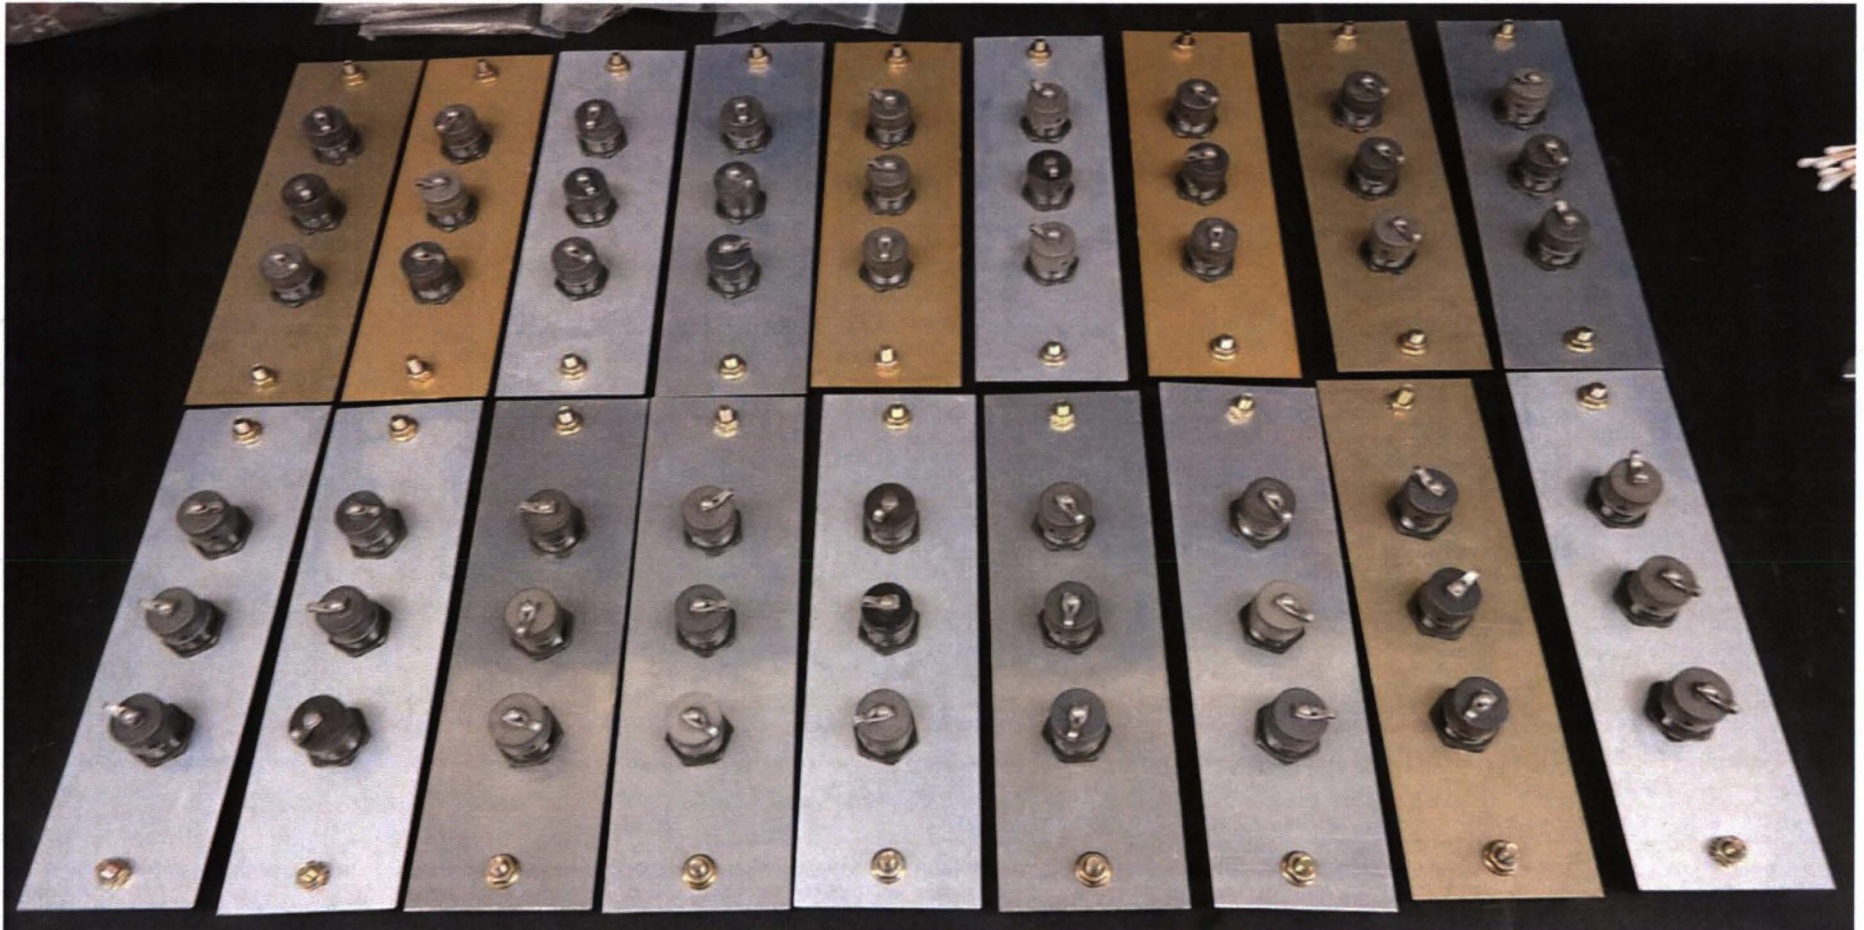
Connector caps added to prevent moisture and salt spray from accumulating inside the connector during beach front testing

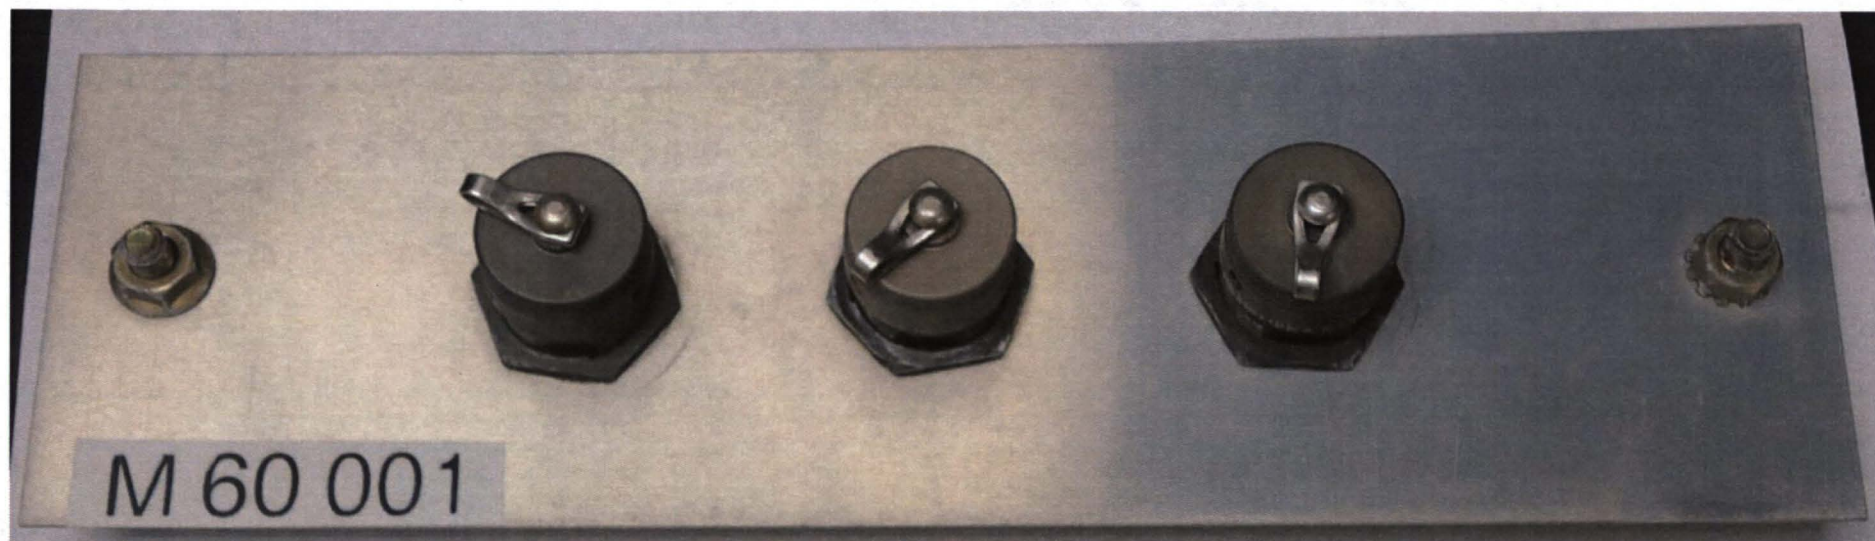
**DC resistance readings from 6061-T6 test panels following 35 days of exposure at
the KSC Beachfront
Metalast TCP HF**

Ground	Connector	Pass	Fail
Stud A	B	0	2
	Hole punched prior to pretreatment CERAN HVA grease used during install		
	C-1	2	0
	Hole punched after pretreatment CERAN HVA grease used during install		
	C-2	0	2
	Hole punched after pretreatment No CERAN HVA grease used during install		
Stud D	B	0	2
	Hole punched prior to pretreatment CERAN HVA grease used during install		
	C-1	2	0
	Hole punched after pretreatment CERAN HVA grease used during install		
	C-2	0	2
	Hole punched after pretreatment No CERAN HVA grease used during install

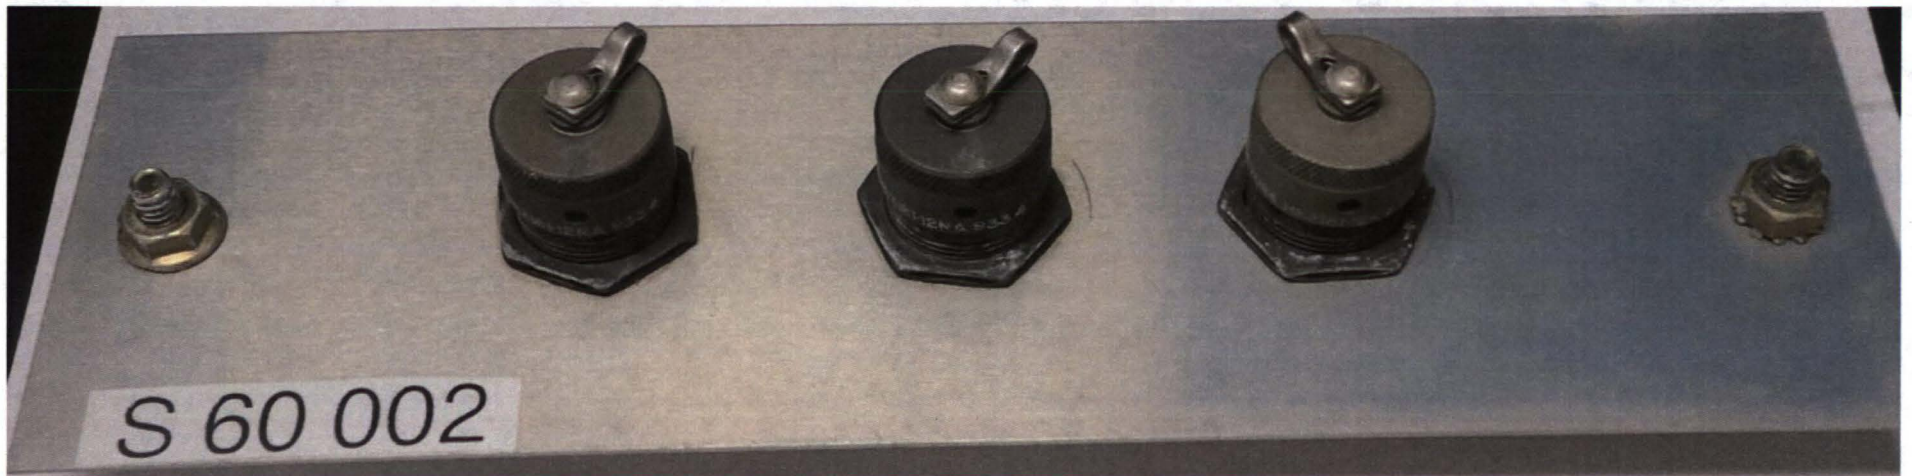
6061-T6 test panels following 35 days of exposure at the
KSC Beachfront

**DC resistance readings from 6061-T6 test panels following 35 days of exposure at
the KSC Beachfront**

Ground	Connector	Pass	Fail
Stud A	B		
	Hole punched prior to pretreatment	1	1
	CERAN HVA grease used during install		
	C-1		
	Hole punched after pretreatment	2	0
	CERAN HVA grease used during install		
Hole drilled prior to pretreatment	C-2		
CERAN HVA grease used during install	Hole punched after pretreatment	0	2
	No CERAN HVA grease used during install		
Stud D	B		
	Hole punched prior to pretreatment	1	1
	CERAN HVA grease used during install		
	C-1		
	Hole punched after pretreatment	2	0
	CERAN HVA grease used during install		
Hole punched after pretreatment	C-2		
No CERAN HVA grease used during install	Hole punched after pretreatment	1	1
	No CERAN HVA grease used during install
